## SafetyOn Research report

An investigation into the root causes of fires  
in MW scale wind turbines

October 2020

Published by  
**Energy Institute, London**

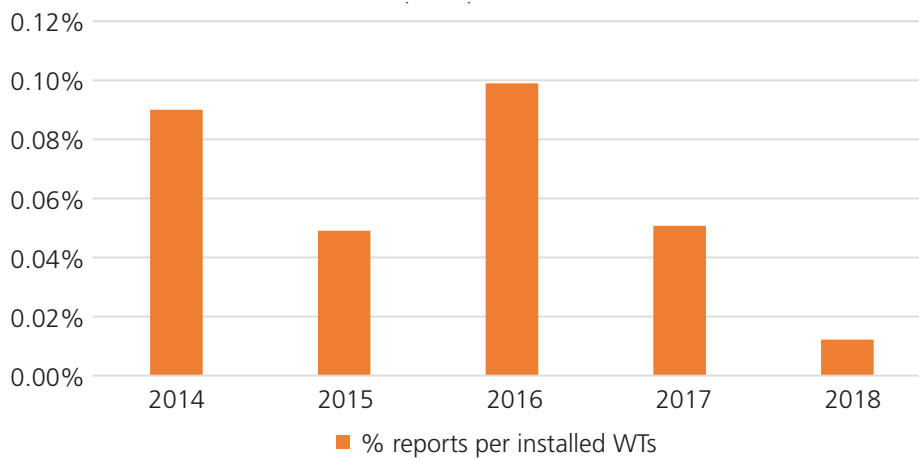
**Figure 1: % reports per installed wind turbines (WT)s**

In order to understand the risk likelihood, especially to understand whether risk was increasing or decreasing through time, an analysis of the number of fires reported per year against the average number of onshore wind turbines installed in the year, determined from industry databases, was performed.

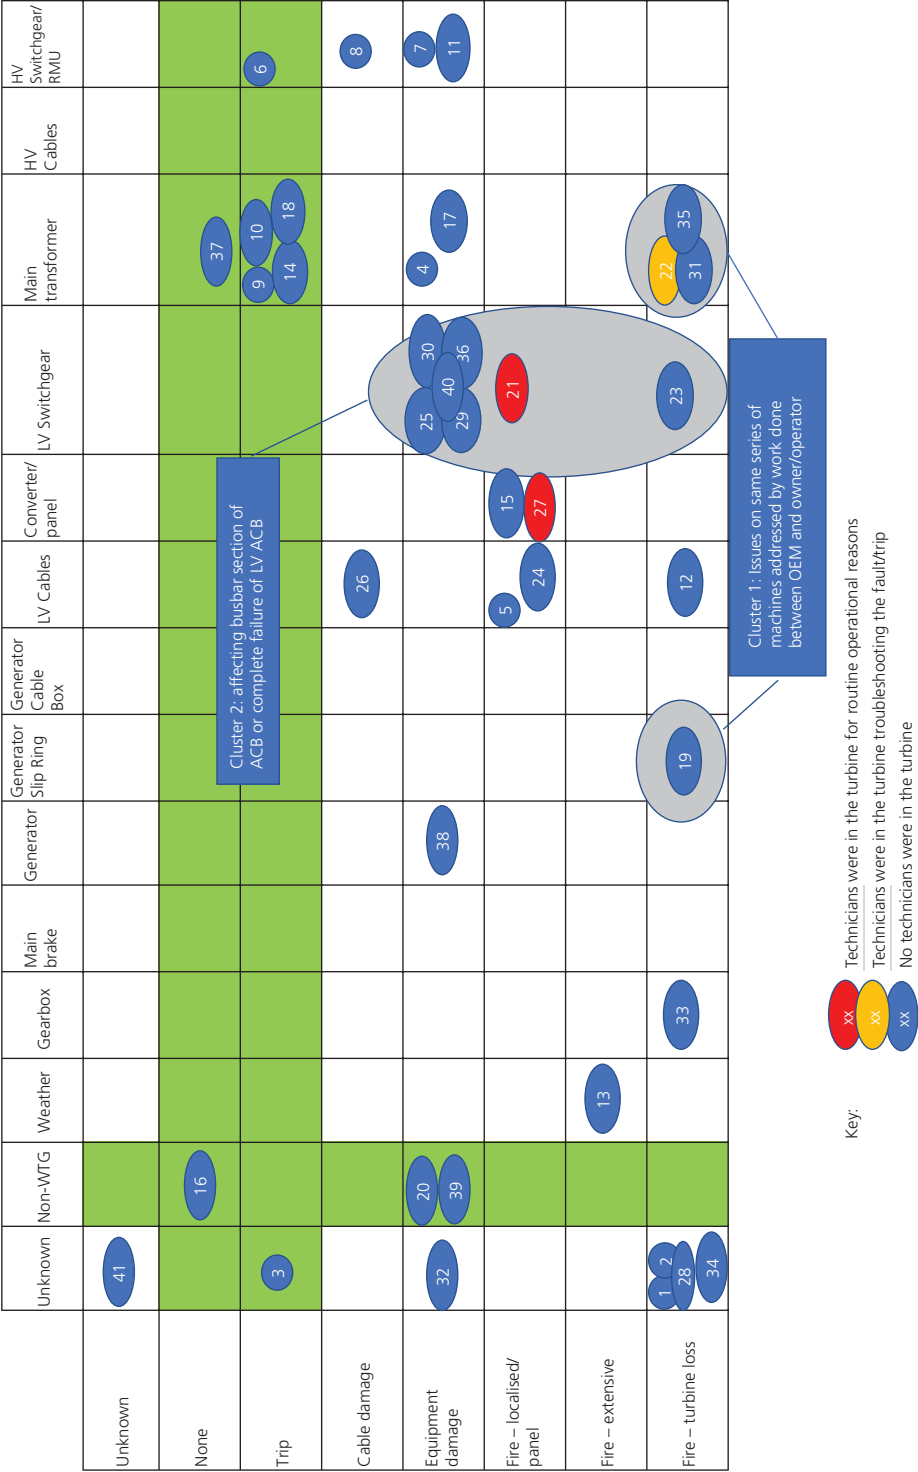
Figure 2: Summary chart of incident causation and effects

Of the 41 incidents reported in the five year period, each was plotted on a chart (fig 2) showing cause categorisation against effect. Known and apparent clusters were identified:

Of the remaining 25 cases, two clusters became apparent.

- One related to transformer fires leading to complete turbines loss and consisted of three cases, with an additional case on the same turbine type being related to the generator. Actions taken to eliminate the causes of these fires by implementation of design changes has already been documented and presented to the HSE and SafetyOn TAC by SPR/SGRE.
- The second appears to relate to LV switch/LV busbar failures, where there have been 7 failures with similar descriptions. Each involved a release of energy which damaged the busbar unit.

This leaves 14 cases where equipment damage of some sort was caused, a localised fire occurred or a significant fire occurred resulting in a complete loss of the turbine. These were spread across 7 of the defined 'systems':

Weather (lightning)	1 case
Mechanical (gearbox, brake, bearings)	1 case
Generator	1 case
LV cables	4 cases
Convertor/main panel	2 cases
LV/HV transformer	2 cases
HV switchgear/RMU	3 cases

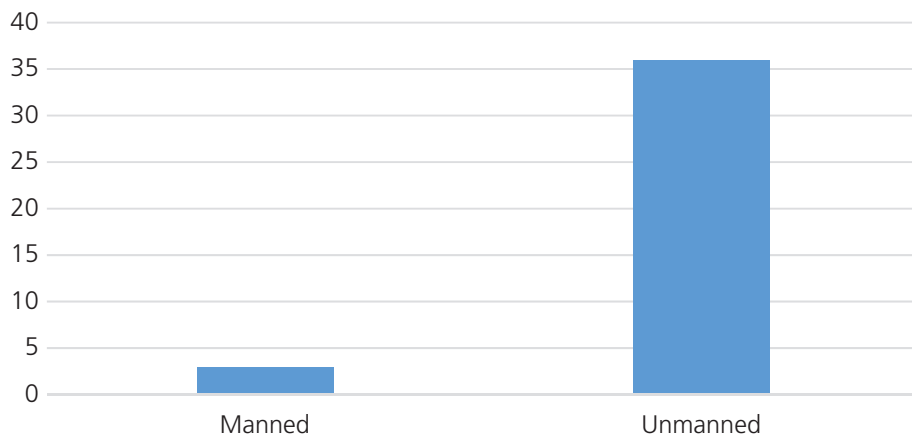
**Figure 3: Analysis of whether turbines were manned at the time of reported incidents**

There have been two cases where the turbine was manned at the time of an incident happening. In both cases, technicians were within the wind turbine carrying out repairs following failures of LV components during operation.

One further case involved a nacelle mounted transformer failure (part of the cluster) which resulted in technicians who were fault finding entering a nacelle, identifying that a fire was smouldering and left the turbine.

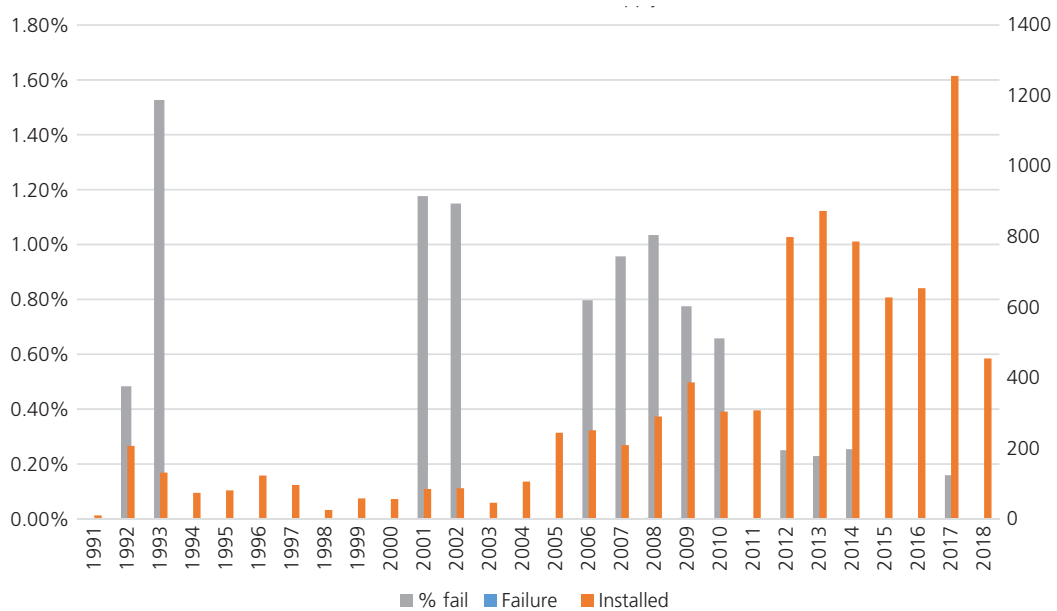
**Figure 4: Failure likelihood based on supply date**

In the figure above, the gold bars show the number of turbines installed in each year (from industry data). The grey bars show the percentage of turbines which appear on the RIDDOR/ESQCR reports between 2014 and mid-2019. There are three data points excluded as the Health and Safety Executive could not identify the site concerned from the report text.

It can be seen that a turbine installed in 2010 or before has a much higher likelihood of suffering a fire related incident which is reported under RIDDOR/ESQCR, than a more modern wind turbine installed since 2011. This data supports the hypothesis that many of the technologies within older wind turbines have been improved over the years and that fire risks are continually reducing.
